Corrosion

Page
Impedance Characteristics of Isolated Aluminum Oxide Films By D. F. MacLennan.....	17
Rates of Dissolution and Passivation of Hafnium-Free Zirconium In Hydrofluoric Acid By M. E. Straumanis, W. J. James and A. S. Neiman.....	20
Performance of Organic Coatings in Tropical Environments By A. L. Alexander, B. W. Forgeson and C. R. Southwell.....	25
Stress Corrosion Crack Paths in Alpha Aluminum Bronze In Ammonia and Steam Atmospheres By J. F. Klement, R. E. Maersch and P. A. Tully.....	29
Factors Affecting the Corrosion of Steel By Oil-Brine-Hydrogen Sulfide Mixtures By Donald W. Shannon and James E. Boggs.....	33
An Analytical Procedure for Testing the Effectiveness Of Hydrogen Sulfide Corrosion Inhibitors By Donald W. Shannon and James E. Boggs.....	37
A Laboratory Method for Evaluating Corrosion Inhibitors For Secondary Recovery By T. R. Newman.....	41
Wash Primer Development and Characteristics By L. R. Whiting..... Discussion: Harold C. Wells, William F. Gross, Page 47; Stanley Roth, Vance N. Jenkins, Austin K. Long, Joe E. Rench, John J. Corely, W. A. Severance, Kenneth E. Wright, Page 48; Replies by L. R. Whiting, Pages 47 and 48.	45

Evaluation of Protective Co

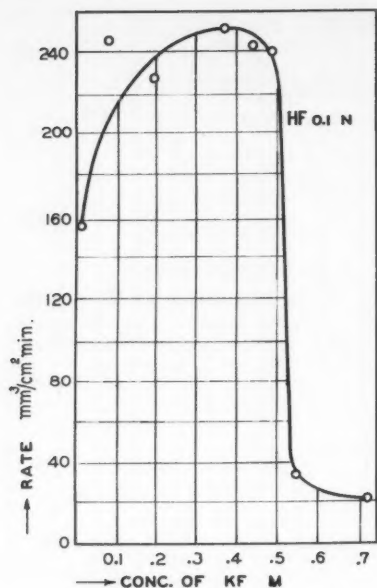
Figure 3—The effect of KF additions in tenths of M on the rate of dissolution of Zr in 0.1N HF at 25 C.

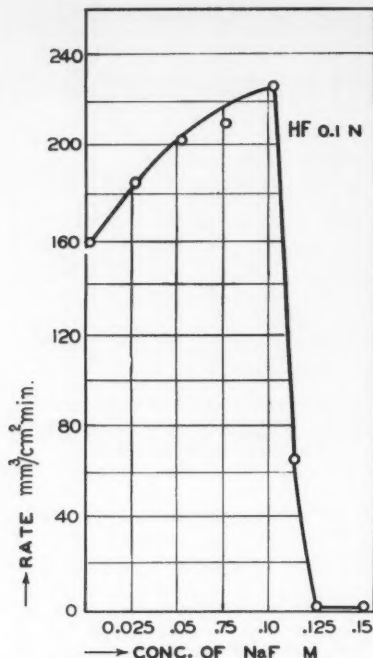
Figure 4—The effect of NaF additions (in hundredths of M) on the rate of dissolution of Zr in 0.1N HF at 25 C.

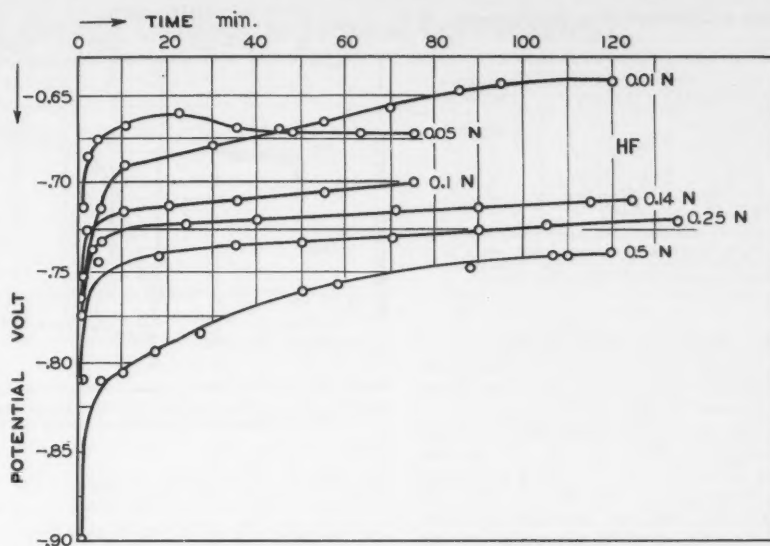
Figure 6—Potential-time curves of Zr in various concentrations of HF .

Two steps in passivation should be distinguished: the one produced by the hydride film and the one by salt additions. It is best for this purpose to analyse the curve (Figure 8). As already mentioned, the oxide film on the surface of Zr may cause a fairly positive potential of the metal in HF . Evidently this film dissolves so fast in HF that it is not possible to observe the drop in potential, but only the rise which is due to formation of a partially protective porous hydride film on the surface of Zr due to hydrogen liberation according to reaction (1).

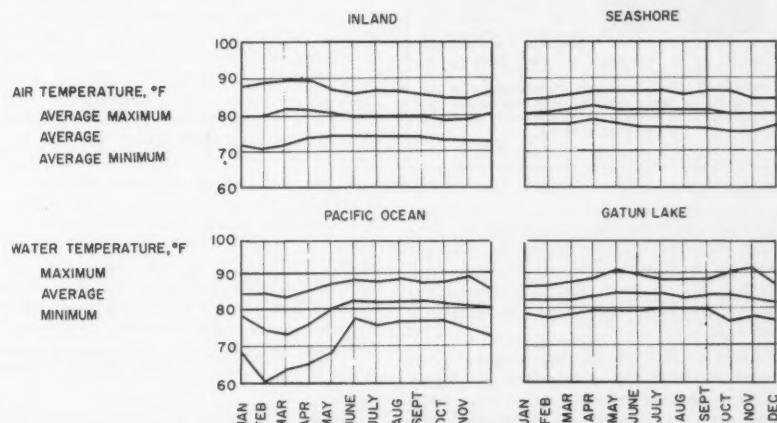
Figure 1—Temperatures for water and air exposures in Panama Canal Zone.

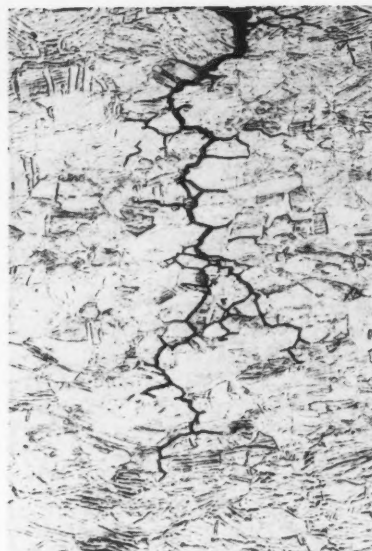
Figure 1—Intergranular cracking in 5 percent Al, 95 percent Cu alloy stressed at 30,000 psi in 350 F steam atmosphere. 100X.

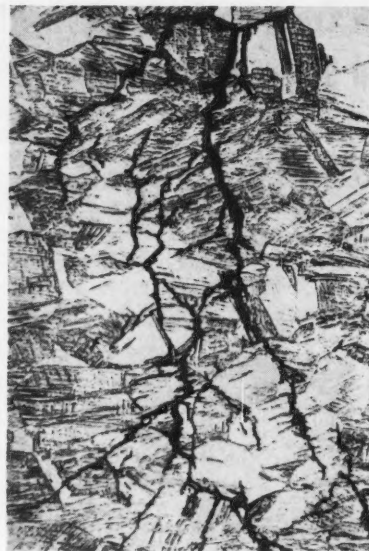
Figure 2—Intergranular and transgranular crack path in 5 percent Al, 95 percent Cu alloy stressed at 30,000 psi in room temperature ammonia atmosphere. 150X.

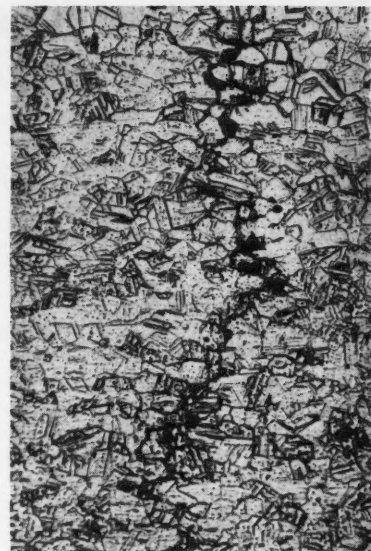
Figure 3—Intergranular cracking in 6.5 percent Al, 2.5 percent Fe, 91 percent Cu alloy stressed at 30,000 psi in 350 F steam atmosphere. 50X.

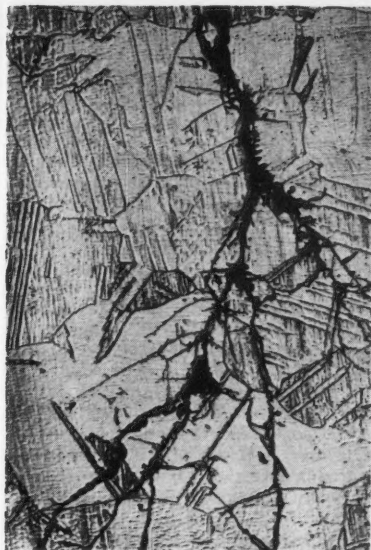
Figure 4—Transgranular crack path in 6.5 percent Al, 2.5 percent Fe, 91 percent Cu alloy stressed at 30,000 psi in room temperature ammonia atmosphere. 250X.

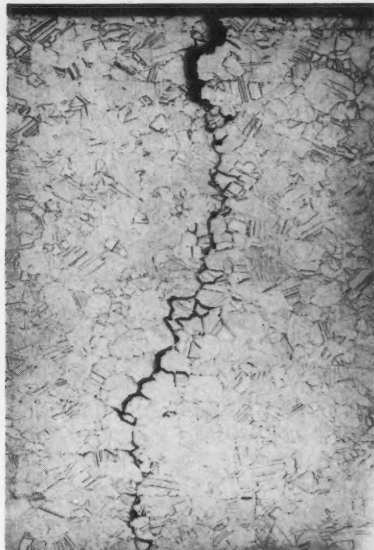
Figure 5—Intergranular crack path in 8 percent Al, 92 percent Cu alloy stressed at 30,000 psi in 350 F steam atmosphere. 50X.

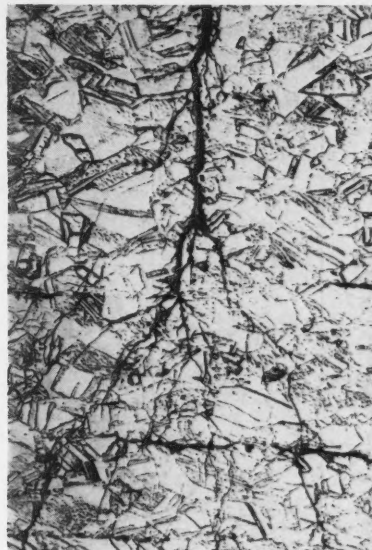
Figure 6—Transgranular cracking in 8 percent Al, 92 percent Cu alloy stressed at 30,000 psi in room temperature ammonia atmosphere. 90X.

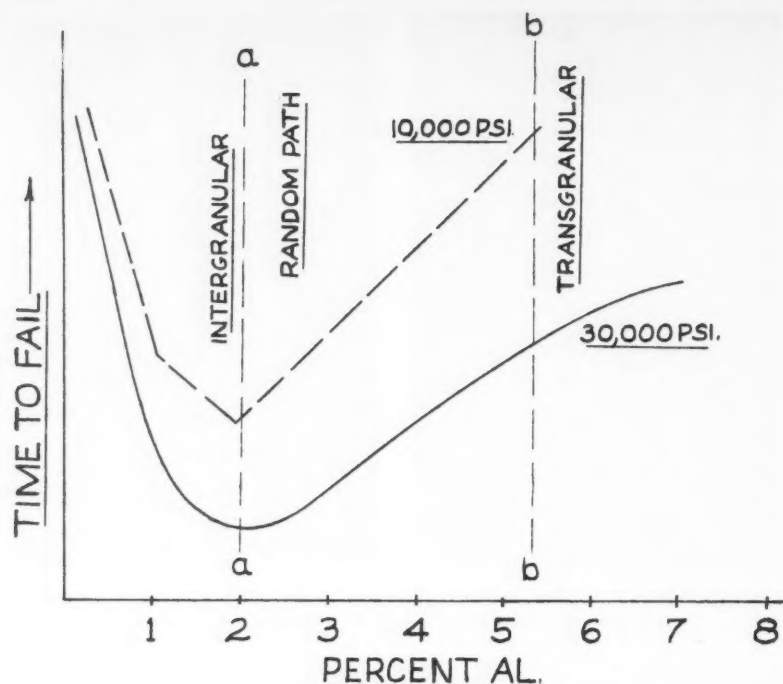
Figure 7—Graphical representation of the stress corrosion cracking susceptibility of alpha aluminum bronze in ammonia atmosphere.

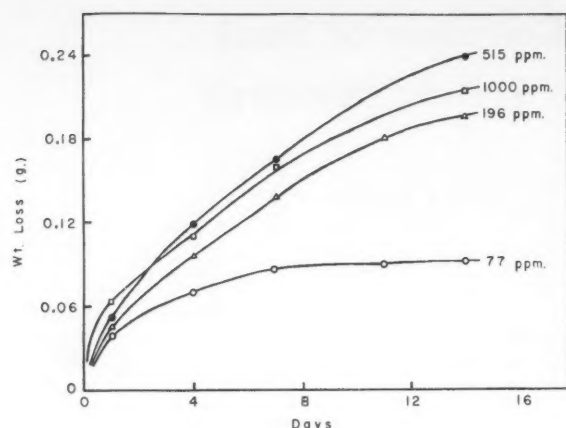
Figure 1—Extent of corrosion as a function of time.

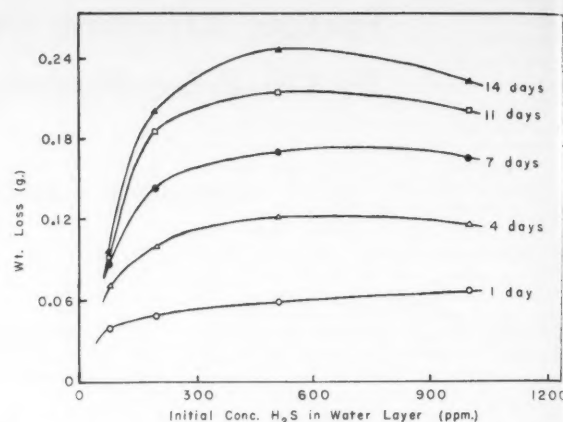
Figure 2—Extent of corrosion as a function of initial hydrogen sulfide concentration.

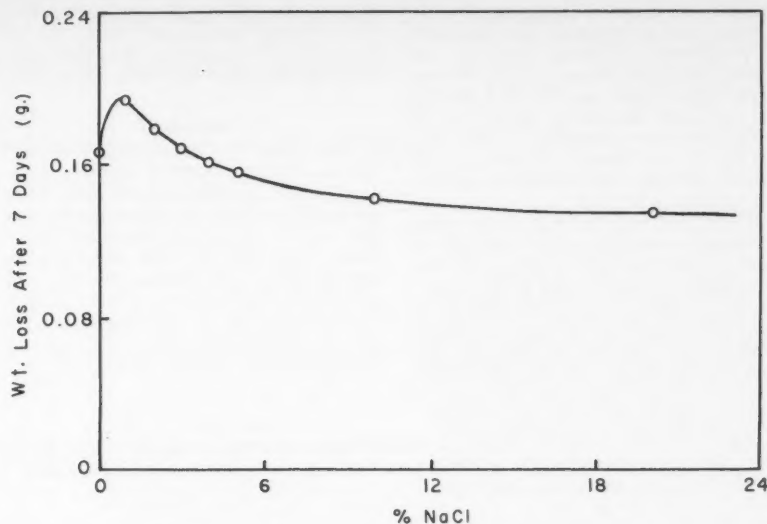
Figure 4—Extent of corrosion as a function of salt concentration.

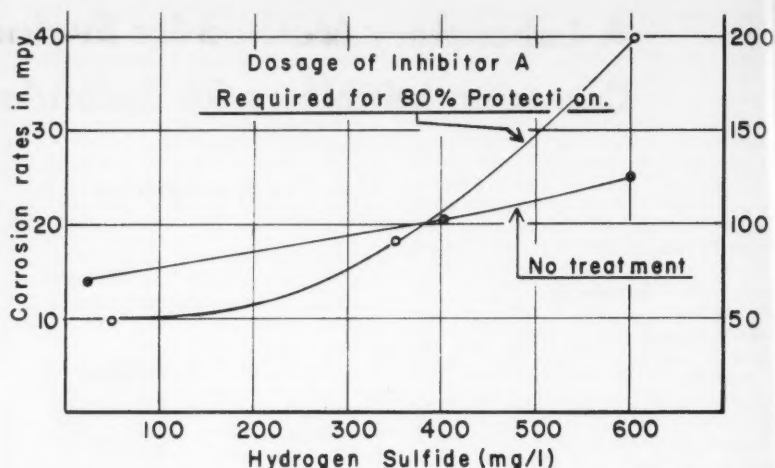
Figure 4—Corrosivity of 10 percent brine containing hydrogen sulfide and less than 1 mg/liter of dissolved oxygen.

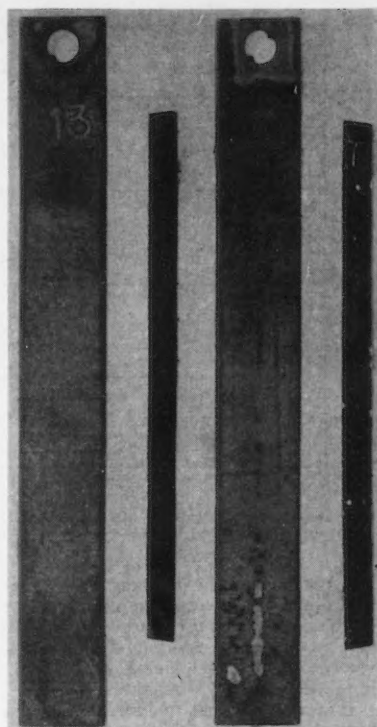
Figure 5—Probe elements from Figure 4 tests.

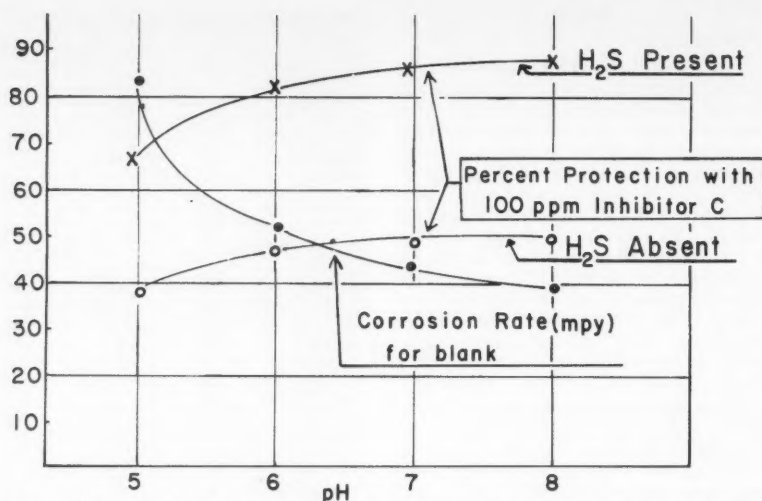
Figure 6—Relationship between pH and corrosivity in 3 percent brine containing 10 mg/liter hydrogen sulfide and 4 to 5 mg/liter of dissolved oxygen.

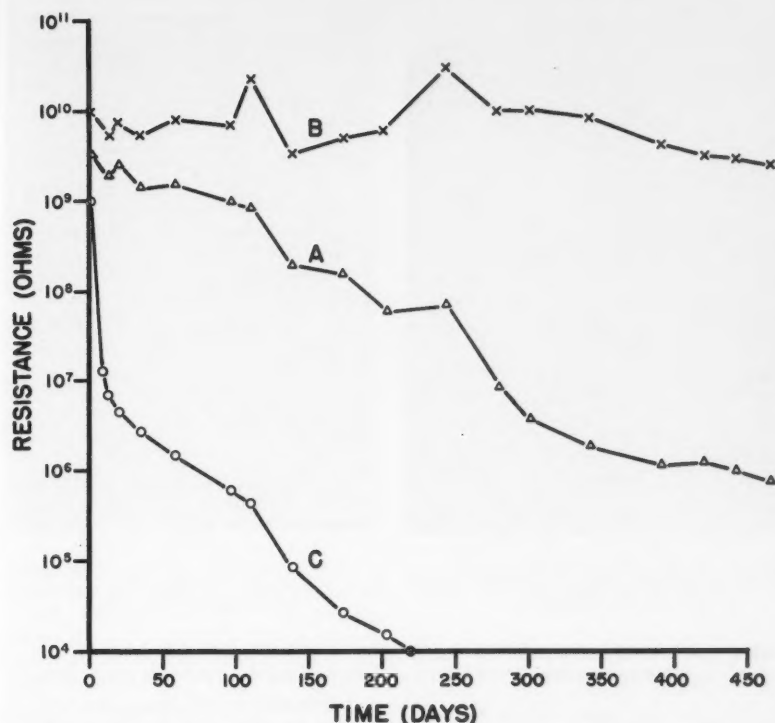
Figure 6—Comparison of three coating systems in static immersion using the d-c resistance method. Curve A is a coating system using one coat each of wash primer, anti-corrosive primer, intermediate primer and anti-fouling. Curve B is the same system as Curve A except that intermediate primer coat is replaced by a second anti-corrosive primer coat. Curve C is a coating system using one coat of wash primer, two of anti-corrosive primer and one of anti-fouling—all of a different proprietary system from Curves A and B.

Comparison between A and C has been confirmed in a ship trial which took 14 months. After that period the difference between the two systems was small enough to make visual comparison uncertain. By comparison, the data obtained in the laboratory permitted clear differentiation. In a service trial, difference between A and B probably would be obscured by the other variables.

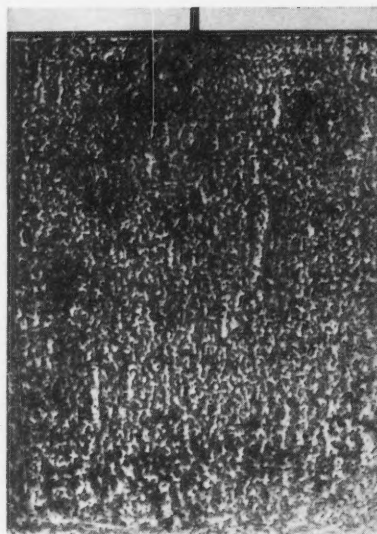
Figure 9—Test panel condition after Treatment No. 3: 1 dip in sea water, 2-day outdoor exposure before painting.

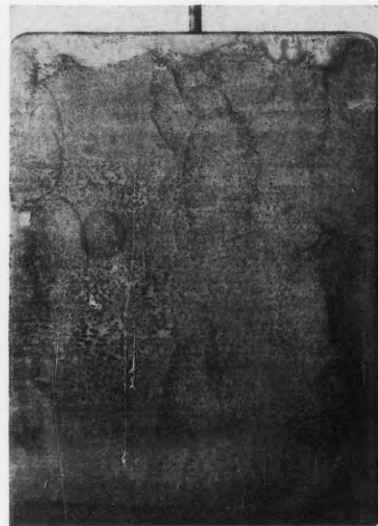
Figure 11—Test panel condition after Treatment No. 8: 1 dip in 5 percent H_2PO_4 , 1-day outdoor exposure before painting.

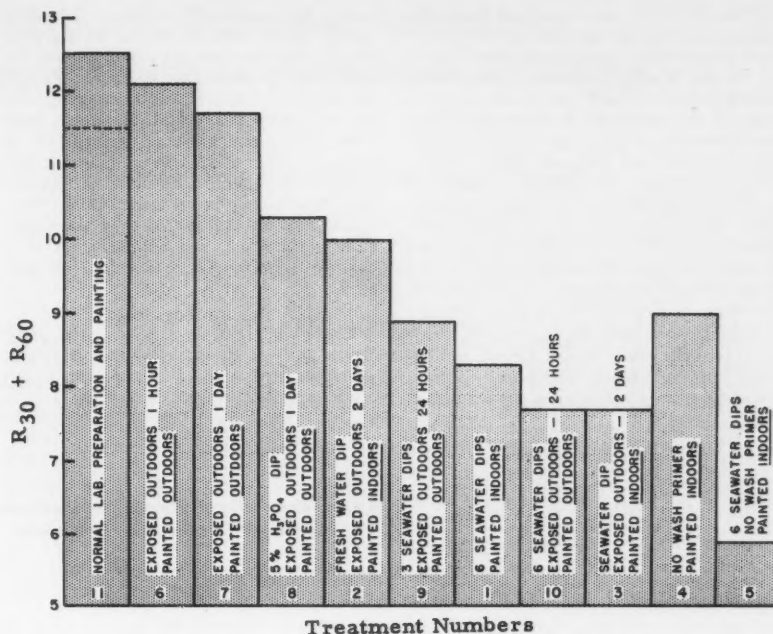
Figure 13—Bar graph showing results of the eleven treatments used on test panels. $R_{30} + R_{60}$ is the average log resistance for sets of panels at 30 and 60 days.

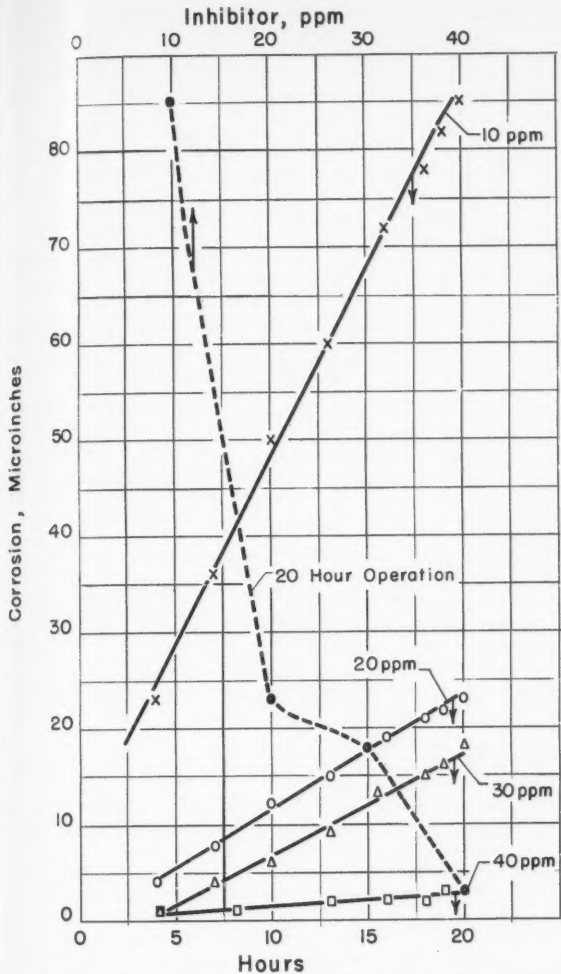
Figure 2—Corrosion rates with inhibitor DD (ASTM D-665-54; MIL-I-25017).

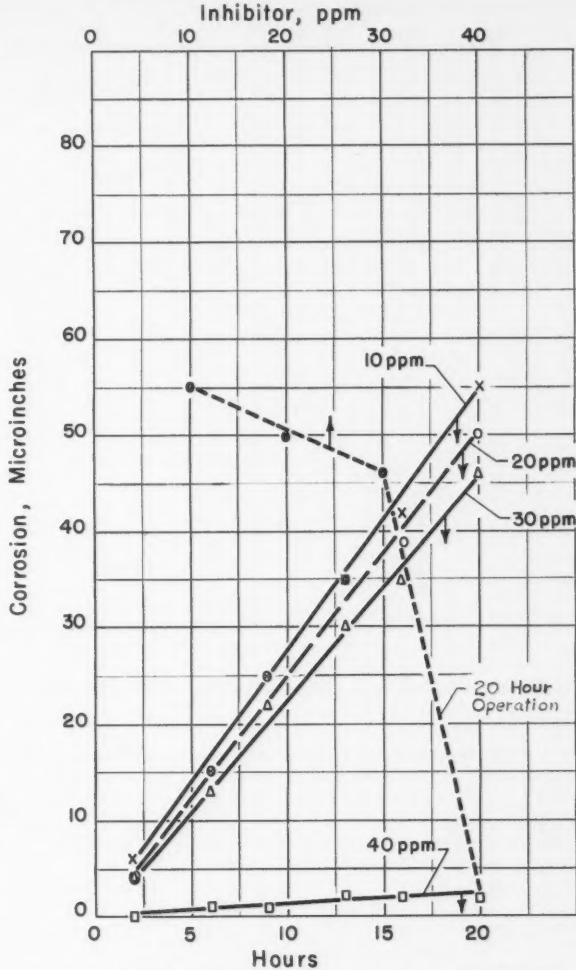
Figure 3—Corrosion rates with inhibitor G (ASTM D-665-54; MIL-I-25017).

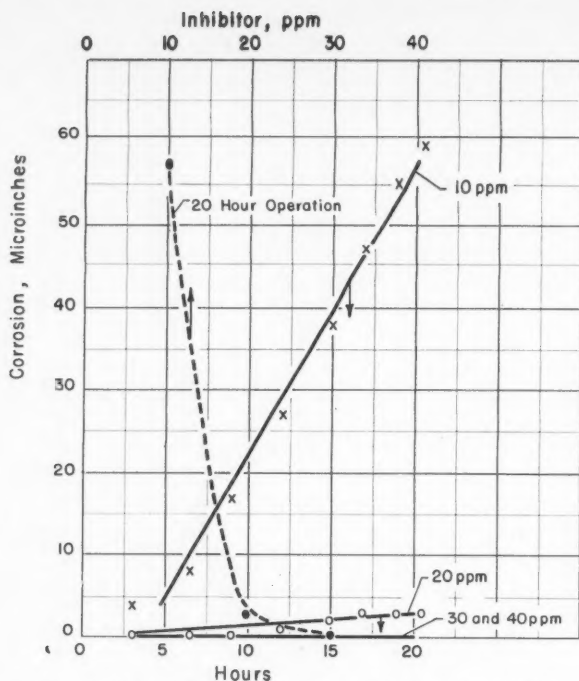
Figure 4—Corrosion rates with inhibitor I (ASTM D-665-54; MIL-I-25017).

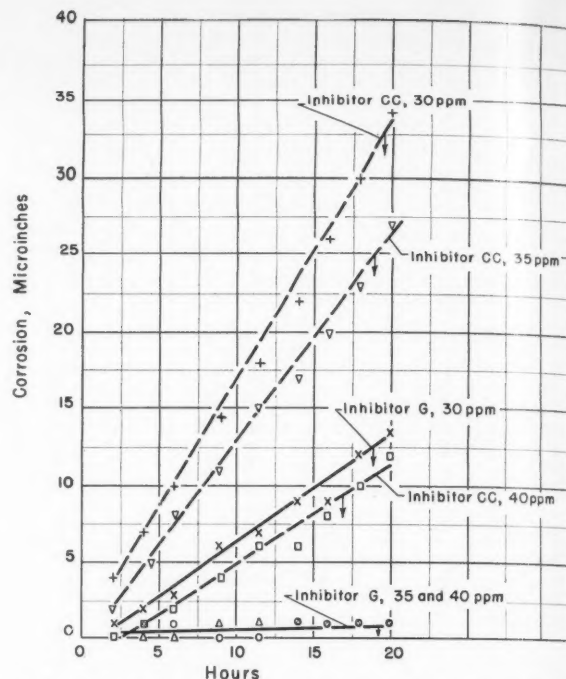
Figure 5—Corrosion rates with inhibitors CC and G (ASTM D-665-54; MIL-I-25017)

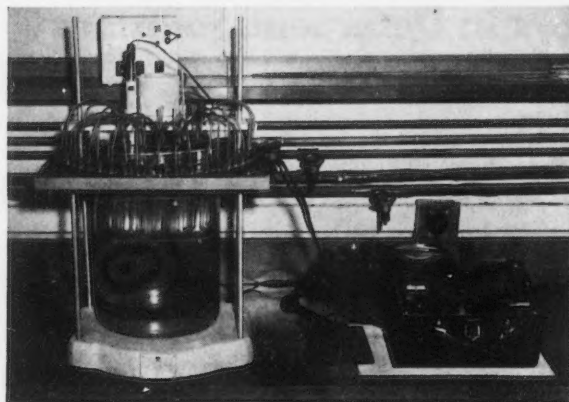
Figure 3—Test equipment used on corrosion testing of die cast materials. Constant temperature bath on the left contains specimens in tubes of corrosive media. Portable double bridge for measuring resistance is shown on the right.

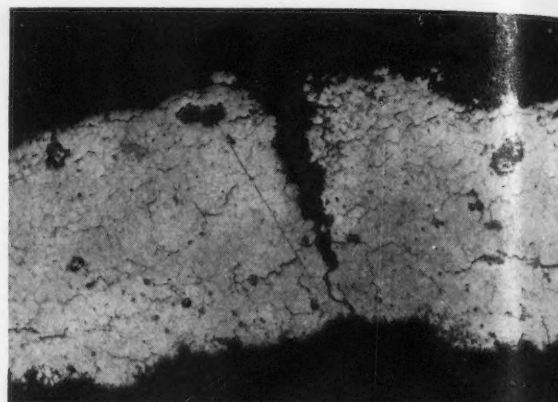
Figure 4—Specimen of Zn die cast material (D3) after 504 hours in a chlorinated detergent solution at 71 C. 200X.

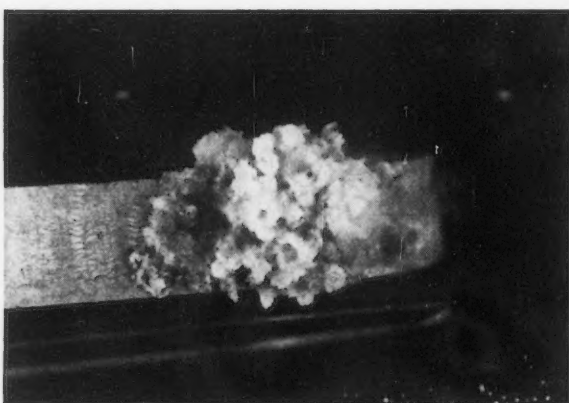
Figure 5—Products of corrosion in place on an A360 aluminum alloy specimen after 648 hours in chlorinated detergent solution at 71 C.

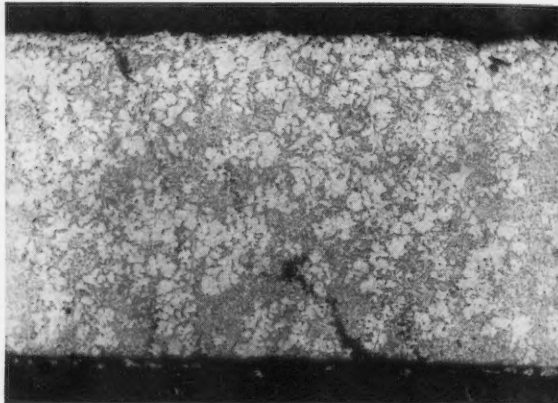
Figure 6—Photomicrograph of same specimen as shown in Figure 5. 200X.

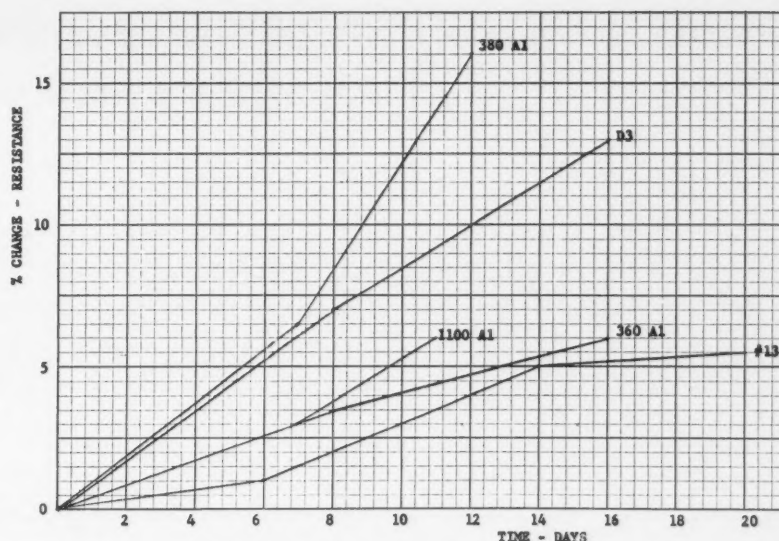
Figure 7—Test results in tap water (stagnant) at 71 C.

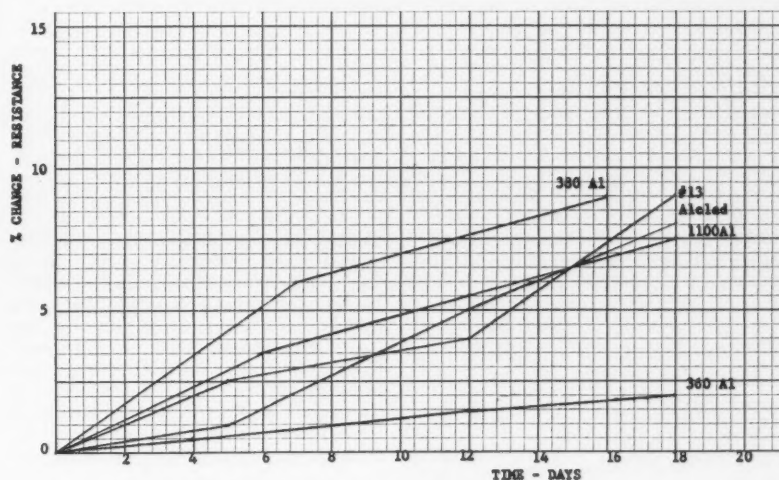
Figure 8—Test results in detergent solution (stagnant) at 71 C.

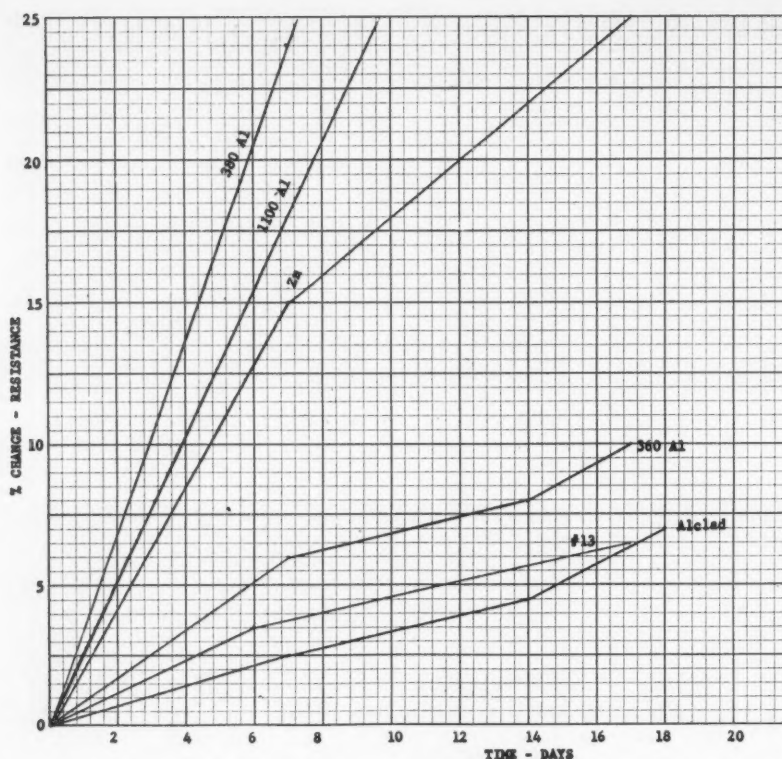
Figure 9—Test results in detergent plus bleach (stagnant) at 71 C.

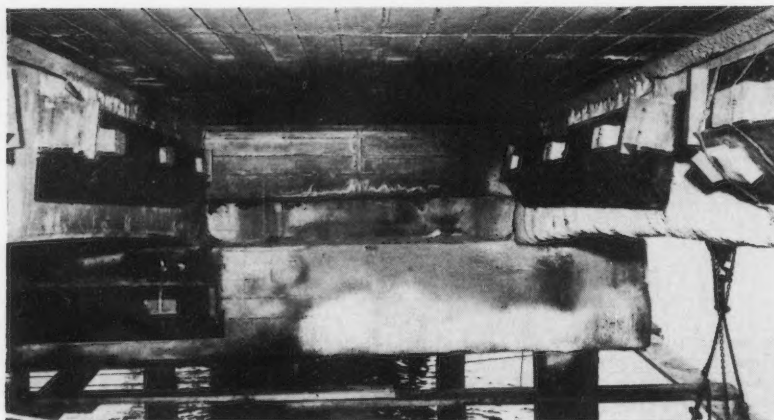
Figure 1—Experimental anode assemblies placed on sides of bridge beams and caps for application of cathode protection.

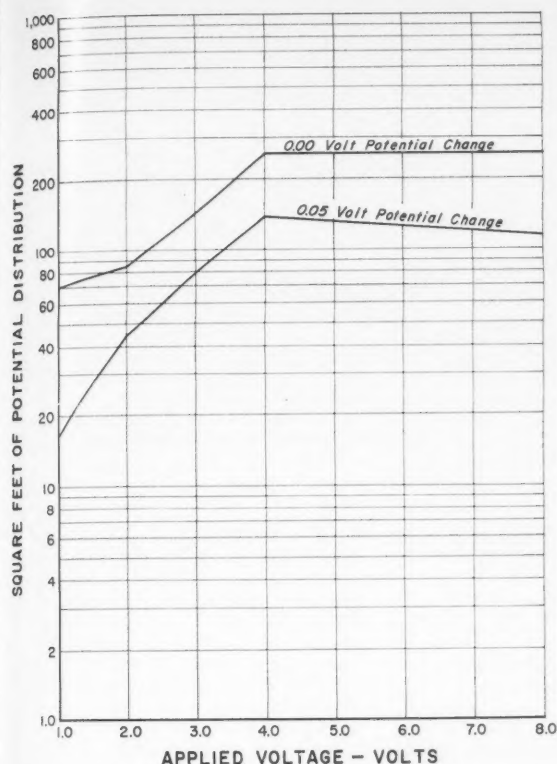
Figure 4—Plot of the area of potential distribution versus applied voltage.

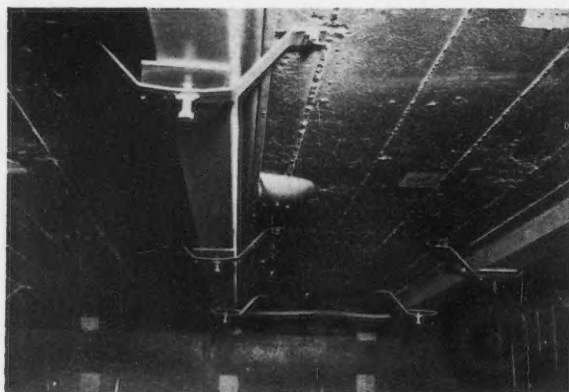
Figure 6—Wetting units attached to underside of bridge deck to add capillary water to the concrete.

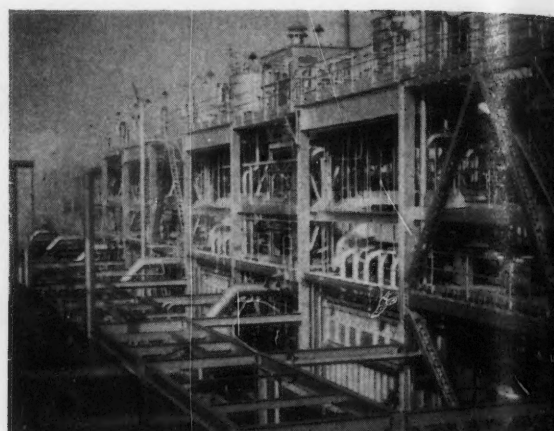
Figure 5—Exposed steel of ocean front steam station at Redondo Beach, Cal.
